Contract Research  
Georgia DOT Research Project No. 2014

Final Report

**DEMONSTRATION PROJECT FOR THERMAL IMAGING  
SAFETY SCREENING SYSTEM**

June 2002

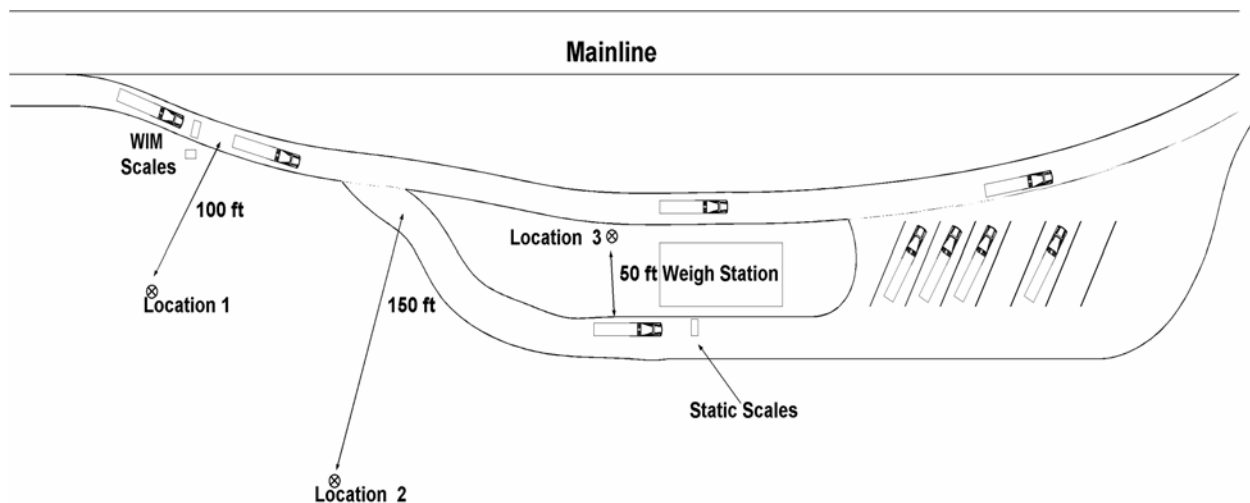
**Figure 1. TISSS Deployment at Douglas Co. Weigh Station**

The system was deployed at the Douglas County weigh station. During the test period, the only failures were related to accidental disconnection of the controller power cord on several occasions. Three different deployment locations were configured in an attempt to optimize the effectiveness and ease of operation. The different deployment locations are shown in Figure 1.

The TISSS was initially deployed at location 1 with the cameras located along the entrance ramp to the Douglas County Weigh Station. There were two problems with this deployment. The first problem was signal interference between the data radio and the visible camera subsystem. This problem was not detected when the system was operating at the GTRI facility since the remote unit was not as far from the base unit. Camera control and IR video operated satisfactorily. The second problem with this configuration was the angular rates at which the vehicles were passing. Due to the layout of the Douglas County Weigh Station, it is only possible to place the camera system approximately 100 feet from the ramp at this location. At the typical speeds of vehicles at this location (posted at 30 mph, however most vehicles appeared to exceed this), the angular rate required was less than the 40 deg/sec specification for the azimuth rate, however it was difficult to manually follow the vehicle and observe the brake drum temperatures.

The second deployment at location 2 was at a location adjacent to the ramp "Y" to the static scales. The area is cleared further back and a distance to the ramp was approximately 150 feet. The increased distance combined with the slower vehicle speeds (vehicles must slow down as they approach the static scales) produced much lower angular rates for following a vehicle. Good data was taken from this position.

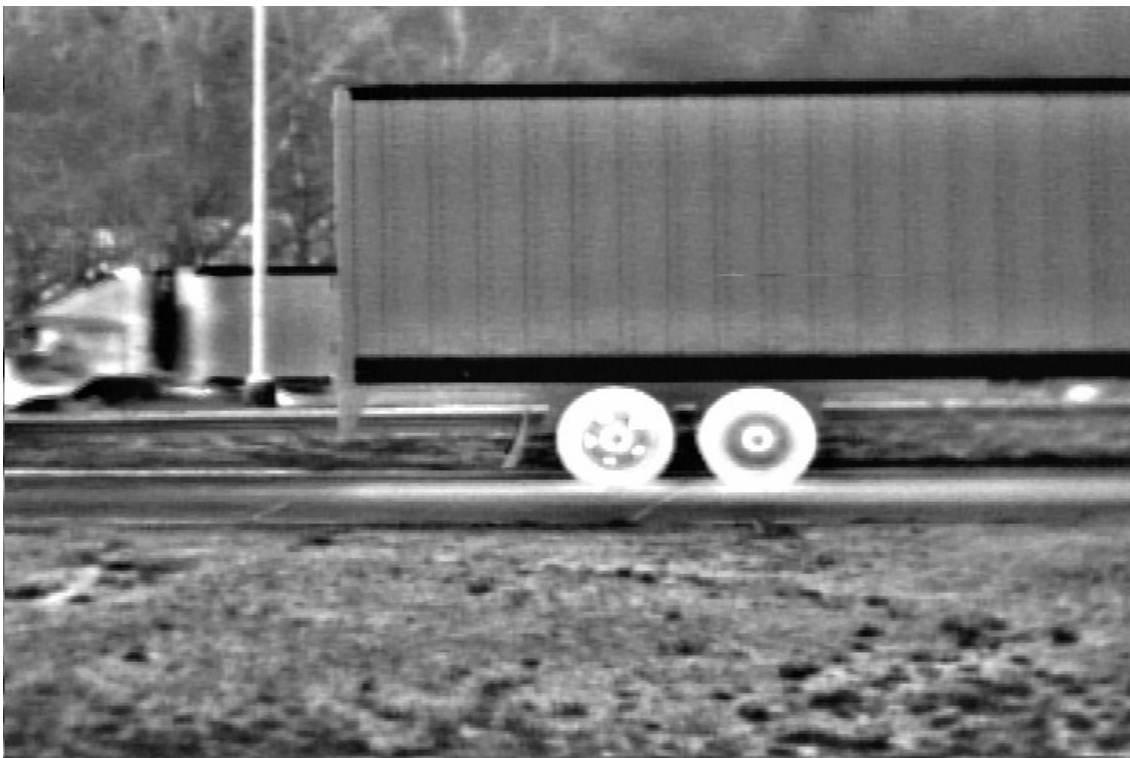
**Figure 2. Location 2 - Trailer with defective brake**

Figure 2 clearly shows a defective brake on the right-forward wheel. The hot brake drum can be seen through the wheel on the left or back wheel. On the right or front wheel, the brake drum appears to be the same temperature as the wheel. Both tires appear to be the same temperature. This trailer was inspected and the brake failure was verified. In Figure 3, the three forward axles (to the right in the picture) were equipped with electric brakes, but no braking action was evident. The hot tire on the other side of the trailer can be seen through the second wheel from the left. The temperatures of all six brake drums were measured and were found to be only slightly above ambient temperature.

the vehicle is slowing under braking action. The resulting infrared image of a properly operating brake system shows all brake drums to be hot and at approximately the same temperature. Typical images taken from deployment position two are shown in the following photos.

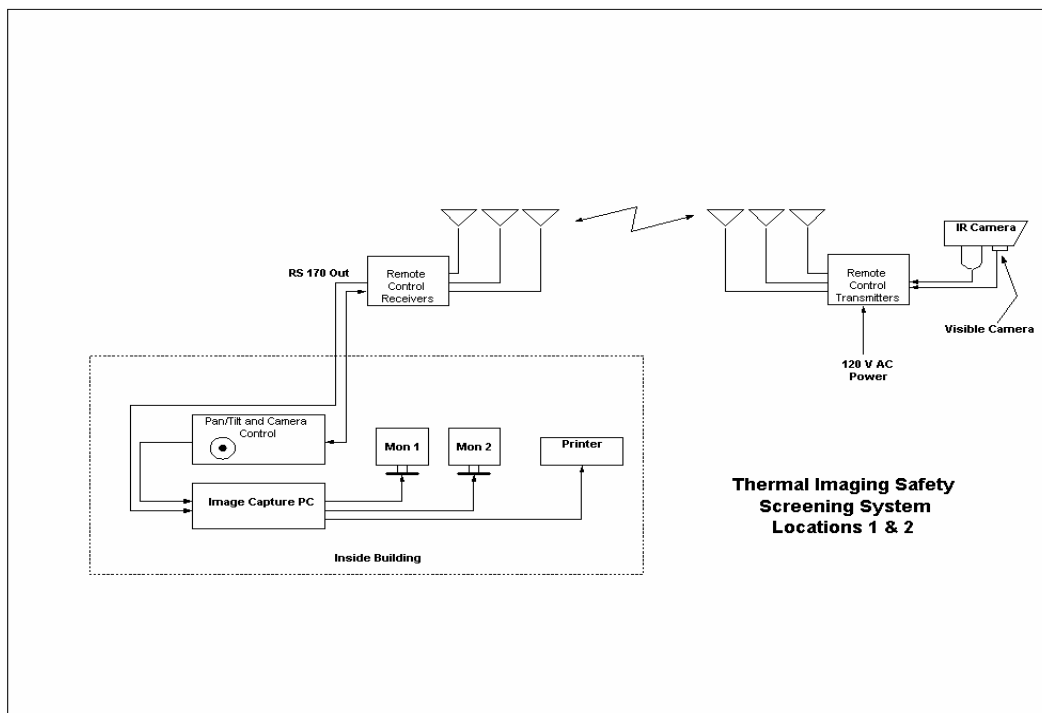
**Figure 4. TISSS deployment with wireless link**

The deployment configuration for locations 1 and 2 is shown in Figure 4.

The interface between the remote unit and the base unit is two 75Ω coaxial cables. In this demonstration system, three radio links; two at 2.4 Ghz and one at 900 Mhz replaced the coaxial cables.

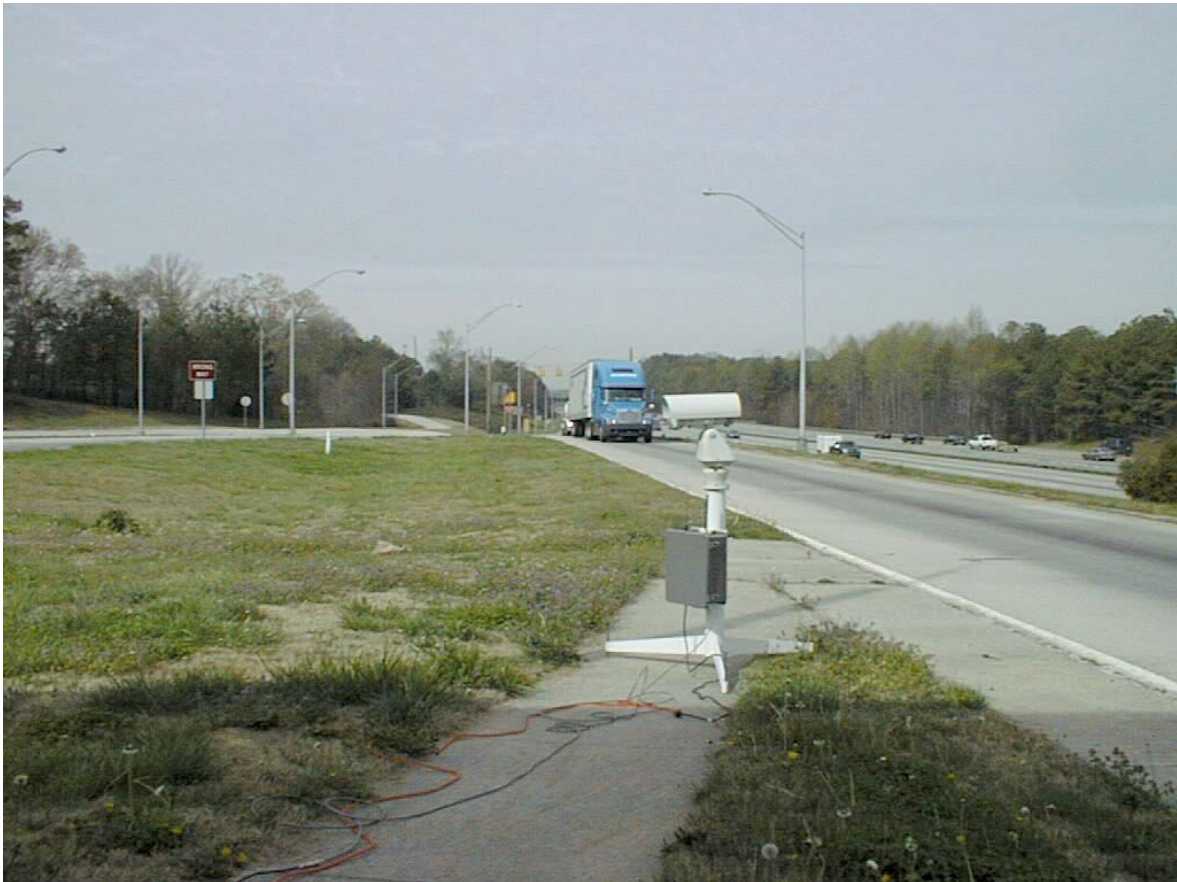
**Figure 5. Location 3 camera deployment – view A**

The third deployment at location 3 was near the weigh station at a location adjacent the point at which the trailer axles are located when the tractor's drive axles are on the static scales. Figure 5 shows the camera system deployed as far back from the static scales as possible. Figure 6 shows a truck approaching the static scales. When the drive axles are on the scales, the camera is directly in-line with the trailer axles. A single coaxial cable is used to transmit infrared video to the image capture computer and to provide positioner and camera control. An extension cord provided the 110V AC.

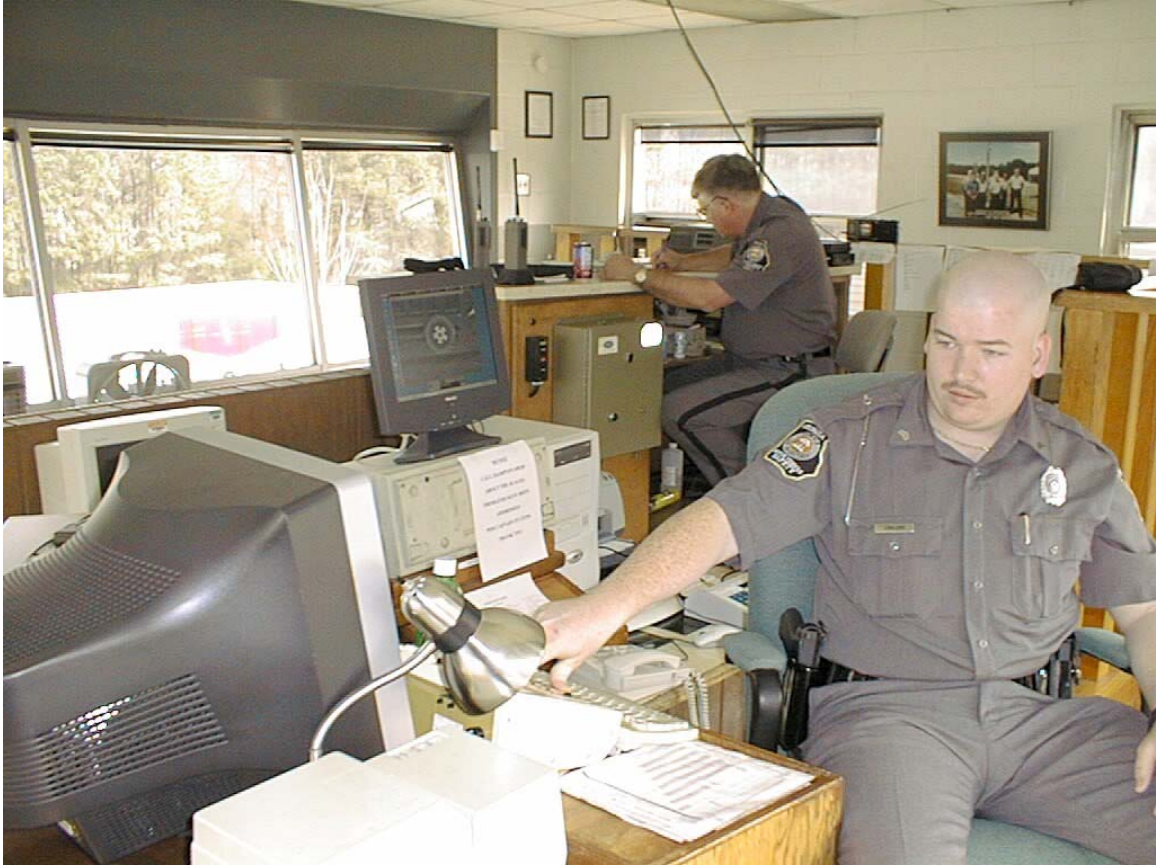
**Figure 7. Location 3 – Weigh Station Video Capture System Deployment**

The deployment of the equipment in the weigh station was modified to allow the officer operating the static scales to view the infrared display while operating the static scales. Occasionally a minor change in camera position is necessary, however there is time for the scale operator to accomplish this since several seconds are normally required to allow the scales to dampen. Figure 7 shows the infrared image of a trailer axle on the monitor just to the right of the officer. The joystick, the mouse, and the printer are all on the table just to the right of the monitor.

In this deployment, only the infrared camera is displayed since vehicle identification is not an issue. The image is shown on a LCD computer monitor. By clicking on a camera icon on the screen below the image, the infrared picture is automatically printed on an HP InkJet printer. The major advantage is that no additional operators are required. The disadvantage is that only those vehicles that are routed to the static scales are screened. At the Douglas County weigh station, that is not really an issue since a deployment on the ramp does not allow enough time for scanning the truck, making a decision, and routing the vehicle to the static scales. The Douglas County weigh Station is not open around the clock. Due to the potential for vandalism when the weigh station is closed and unmanned, the officers returned the camera assembly to the station nightly. This is a cumbersome process at best and hazardous to the equipment at worst. The system configuration for deployment in location 3 is shown in Figure 8.

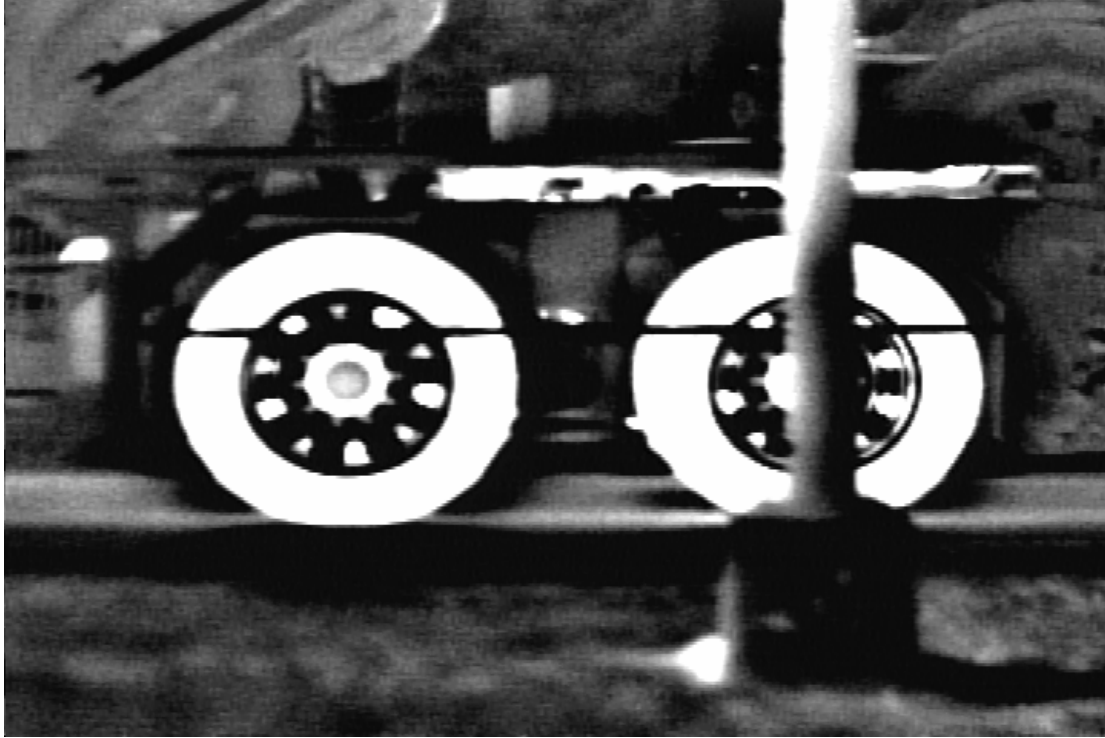
**Figure 9. Location 3 – Typical trailer brakes image**

A typical image at this deployment location is shown in Figure 9. This trailer had both brakes operating properly and the hot brake drums can easily be seen through the wheels.

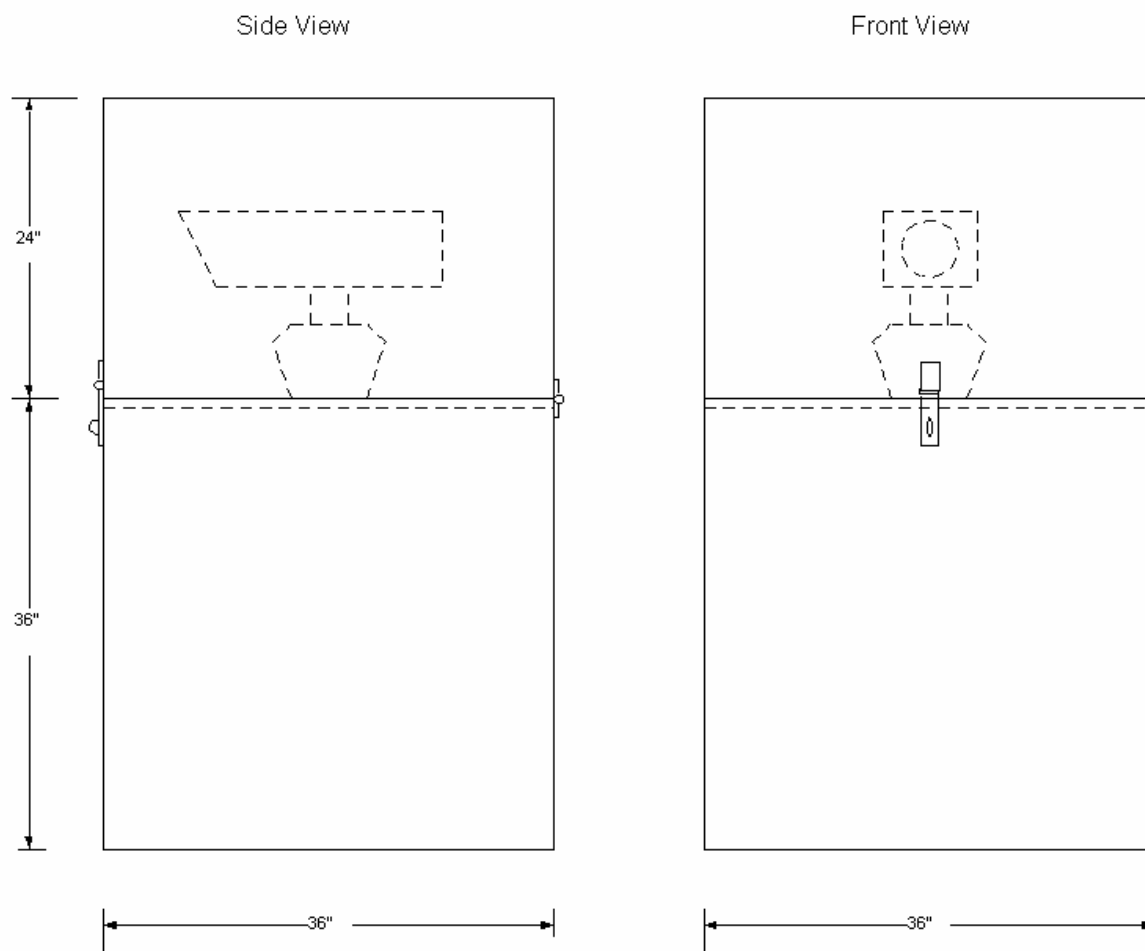
**Figure 10. Security Cabinet Dimensions**

One issue that the author did not anticipate is vandalism. The camera needs to be mounted near the ground in order to be able to look through the wheel holes (and under the truck/trailer to see the brake drums on the opposite side). This deployment obviously puts the camera in harms way with respect to vandals. A lockable cabinet with a hinged cover is suggested. Dimensions for the suggested cabinet are shown in Figure 10.

Two  $\frac{3}{4}$ " PVC conduits should be provided for wiring between the security cabinet and the weigh station. One conduit should contain a single RG6 cable terminated with 75 ohm, BNC-male connectors at each end and the other should contain a single twisted-shielded-pair 16 gauge or larger cable such as General Cable Carol Brand no. C2536.
